Scientific paper

Zastita Materijala 63 (4)

Choosing the procedure for repair of damaged arm at an unicate desk lamp

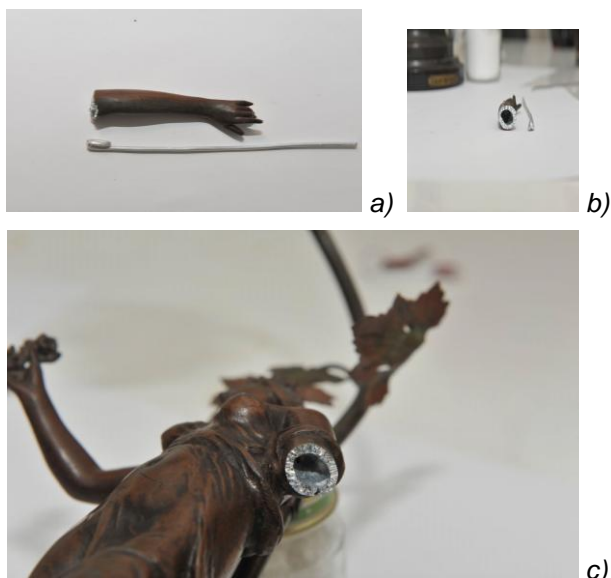
The lamp is damaged at the left side of statue, exactly on the arm near elbow but just over this place, see Fig. 2a). At this place the arm from the lamp was hollow, Fig. 2b).

Figure 2. Broken arm in two views a) and b); look at the lamp from downside c)

The inner diameter of hollow at broken arm was about 10mm, with wall thickness about 2mm. The depth of this hollow part was about 45mm. At the broken wall could be seen the great dendritic grains which is characteristic for as-cast structure of used alloy, see figs. 2b) and c). The hollow arm indicates that the lamp body is produced from various components which are first casted and then connected either by welding or brazing.

At damaged surfaces were not registered any defects originated from a casting period, as like shrinkage, slag or non-metallic inclusions, which generally may appear in as-cast structure, no matter what kind of alloy is used. Generally, as-cast structure is a brittle.

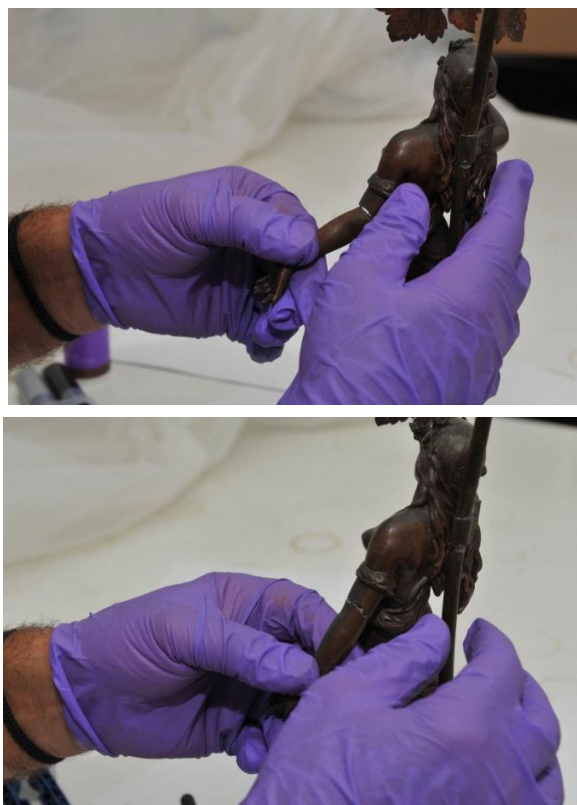
Figure 3. Two views of preliminary assembling of damaged arm to lamp body

The preliminary assembling of damaged arm to the body lamp is shown in Fig. 3. This assembling has confirmed that there is no missing material, what represents a favorable condition in this case. If in contrast, the some piece of material is missing on assembling surfaces that the using of some filler metal will be obvious. But, the choosing and than using of a proper filler metal similar to the parent metal of body lamp, and further its surface regeneration to the original appearance of this unicate piece, will be pretty complex job. It is clear that the achieving the same color of filler metal hardly will be find, may be the whole lamp should be copper plated and lacquered.

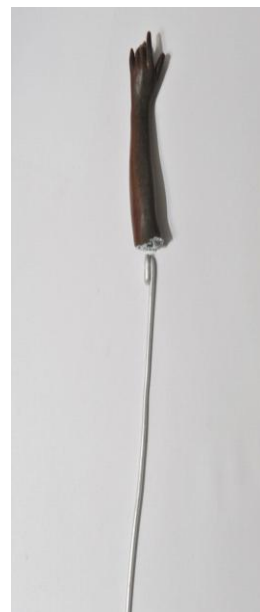
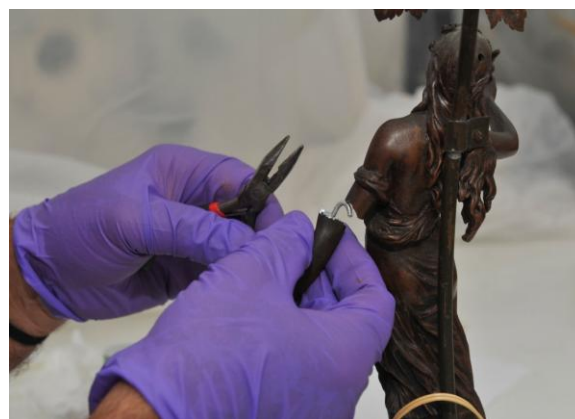
Figure 4. Preparing for reinforcing with aluminum wire

As the third possible way of repairing is considered on reinforcing of glue by inserting an aluminum wire, according to Fig. 4a). It is well known that the aluminum is an inert material in regard to parent material, it is an alloy made of zinc and aluminum, and from that point of view there is no dangerous for corrosion appearance between those materials. But, the limiting factor in this solution is the uncertaintyof such "construction", because it was impossible to fasten the aluminum wire to the lamp body, and then the

As the fourth way for repairing the damaged arm is accepted next solution: at the cavity of lamp body is remained one small pointlike pore, heavy visible. It is beleived that this pore was created during the casting process. But, the diameter of this pointlike pore, less that 0,5mm in diameter, is too small to sguetze through a wire with diameter 3mm, and made a strong connection. In situation like this, is concluced that will be enough first to fasten a screw. A chosen screw is about 20mm in length, $\varnothing 3mm$, and less than 0,5mm in diameter at the top. This steel screw was zinc plated (by using an ordinary galvanic process), what in this situation represents an advantage [12]. The remaining room will be fullfilled by the aluminum wire, Fig. 4b), together with a glue.

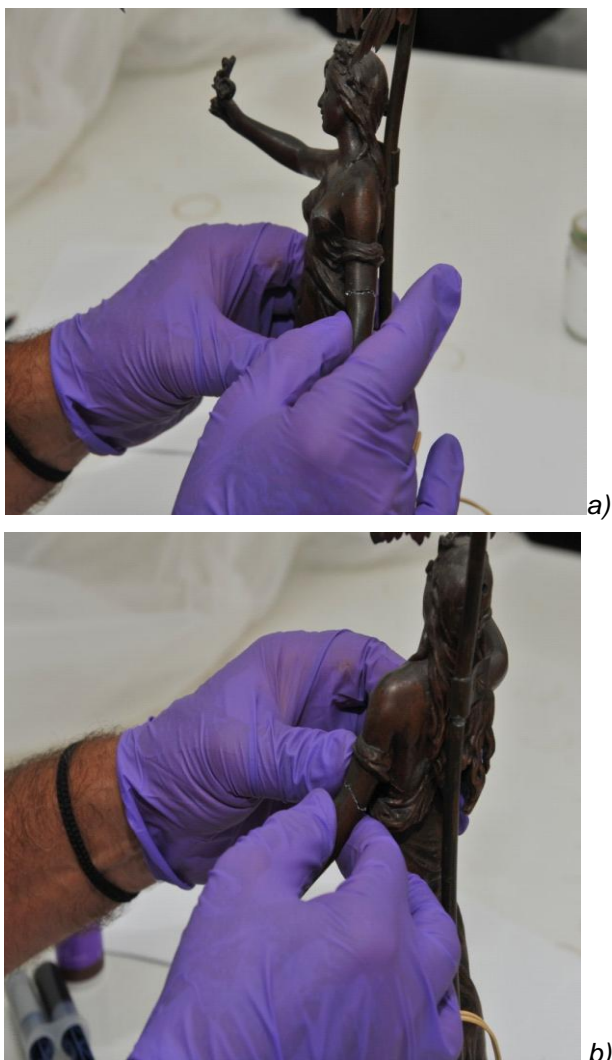
Figure 5. Keeping two components for 6 minutes after all previous works done

The top of the chosen screw is twisted into the small pore, while the head of screw was in position to hang into the hollow of damaged arm. As the screw is made of steel, than the strength of such joint will be satisfied anyway, and at the same time the zinc plated surface is a properly against the parent material, for avoiding a kind of corrosion process. Anticorrosive behavior of coating here means the avoiding so called the contact corrosion of two materials: lamp body from zinc alloy and the zinc plated screw. This way of repairing does not need an application of great amount of glue, so the risk from eventually deformations of relatively thin walls at the arm is really decreased, even eliminated.

The bended end of the aluminum wire is hang on the screw head, and after that the cavity is half fulfilled with two component glue. Such assembly does not contains some substances even in microquantities which would change the surface appearance of the lamp [12-14]. Drying of used glue commonly is pretty short, couple minutes are enough, according to manual instructions of producer. Both parts were sticked together and hold about about 6 minutes, to be sure for obtaining the save connection. At the joined surfaces there were no registered any visible irregularities or deformations, as it was stated in [15]. Views from two side of realised joint at the damaged lamp could be seen at Fig. 5.
