Scientific Paper

Zastita Materijala X (X)
(2024)

Influence of Different Methods of Surface Treatment on Corrosion Resistance of Low-Alloy Steel

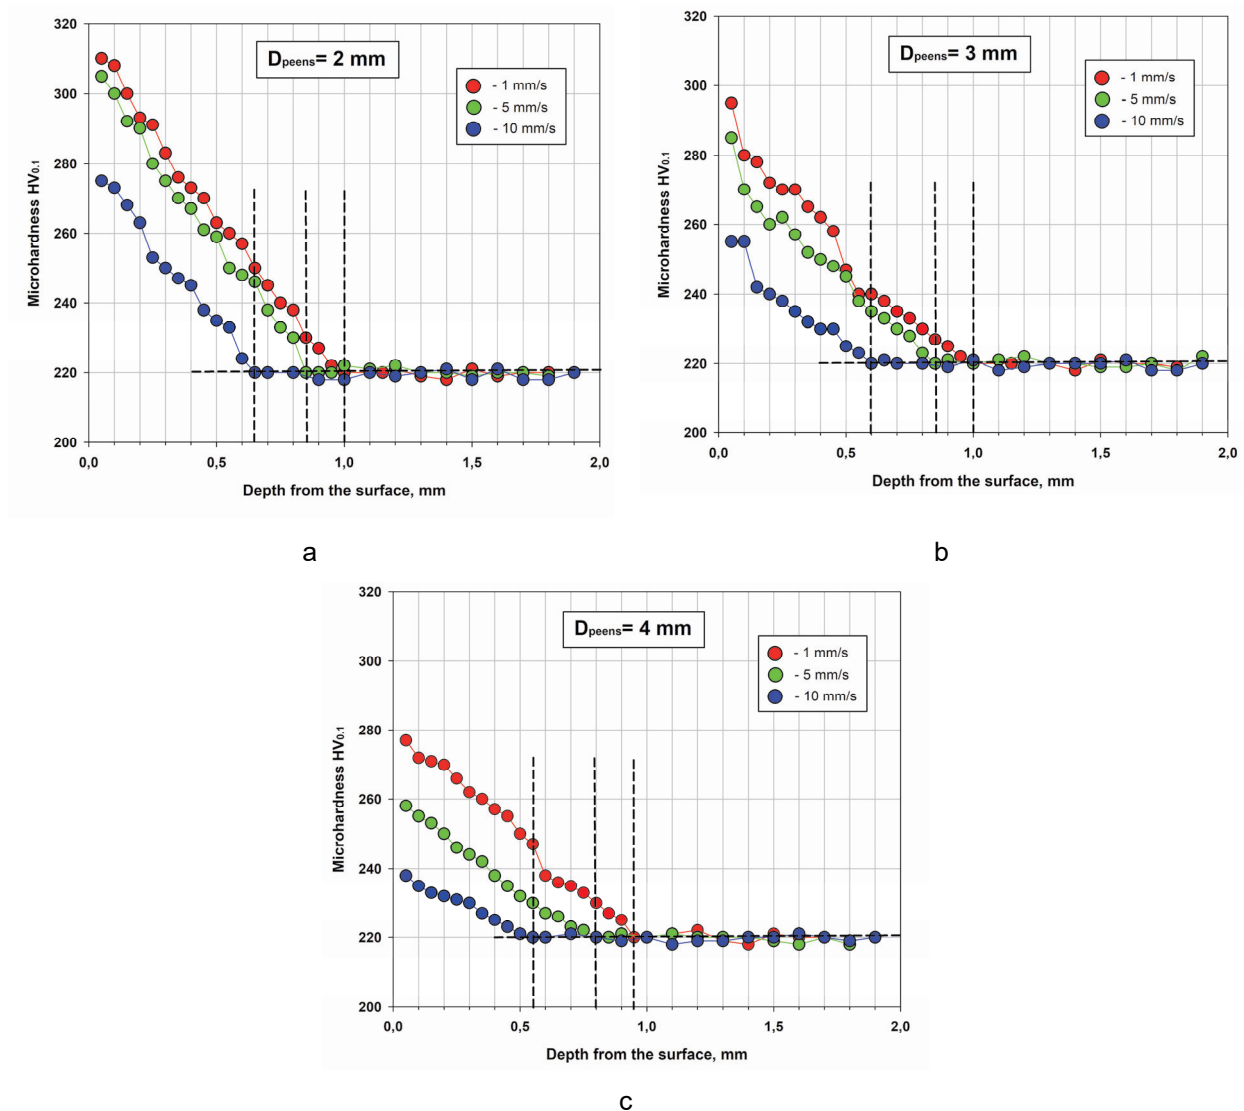
Fig. 1. Dependence of microhardness of near surface metal layer, strengthened by HFMP by using of one-row head with the diameter of cylindrical firing-pins of 2 mm (a), 3 mm (b) and 4 mm (c) from the distance from the bottom of groove to the depth of metal. Speed of implementation of HFMP (Reproduced with permission [15])

Taking into account the above, a hand tool with a removable nozzle was developed for strengthening flat surfaces, in which the impact elements were arranged in several rows. Surface treatment is recommended to be strengthened with circular reciprocating movements at a speed of 35 cm²/min. At the same time, the depth of the strengthened metal layer reached 130-150 microns.

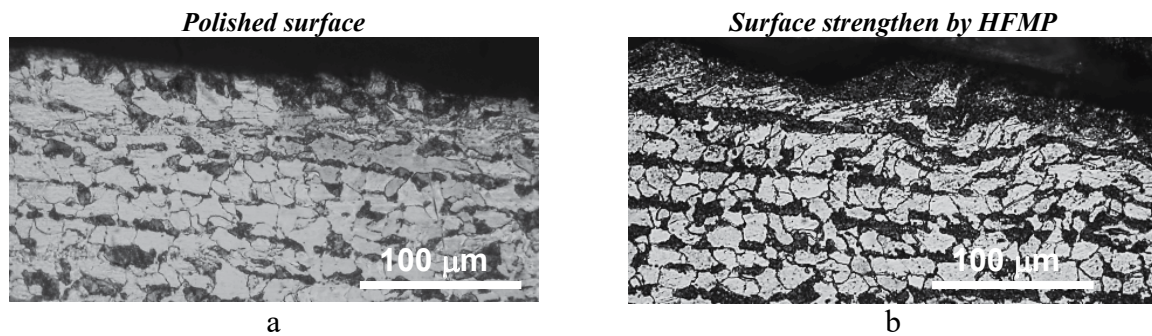
Fig. 2. Microstructure of near surface layers of 15HSND steel with polished surface (P) (a) and surface strengthened by HFMP (b) in the initial state

show photographs of the microstructure of the near-surface layers of 15HSND steel with a polished surface (Fig. 2, a) (hereinafter P) and a surface processed by HFMP (hereinafter P+ HFMP) technology (Fig. 2, b).

It should be noted that the surface P is not completely flat (**Fig. 2, a**) in some areas of the near-surface layers, a different degree of plastic deformation is observed, which leads to a change in the shape of the grains of ferrite and pearlite, with a shape factor from 1.8 to 4, the depth of penetration of plastic deformation is from 0.03 mm to 0.08 mm. After HFMP (**Fig. 2, b**), the surface of the specimen acquired uneven waviness, in the zone with more intensive deformation - from 0.06 mm to 0.08 mm. A change in the shape of the grains, their extraction with a shape factor from 3 to 5, grinding and the more frequent appearance of second-phase dispersed discharges were noted. In the zone with a lower degree of deformation, with a depth of 0.09 mm

to 0.13 mm, practically no change in the shape of the grains was observed, only the distortion of the ferrite-pearlite striation of the structure was noted.

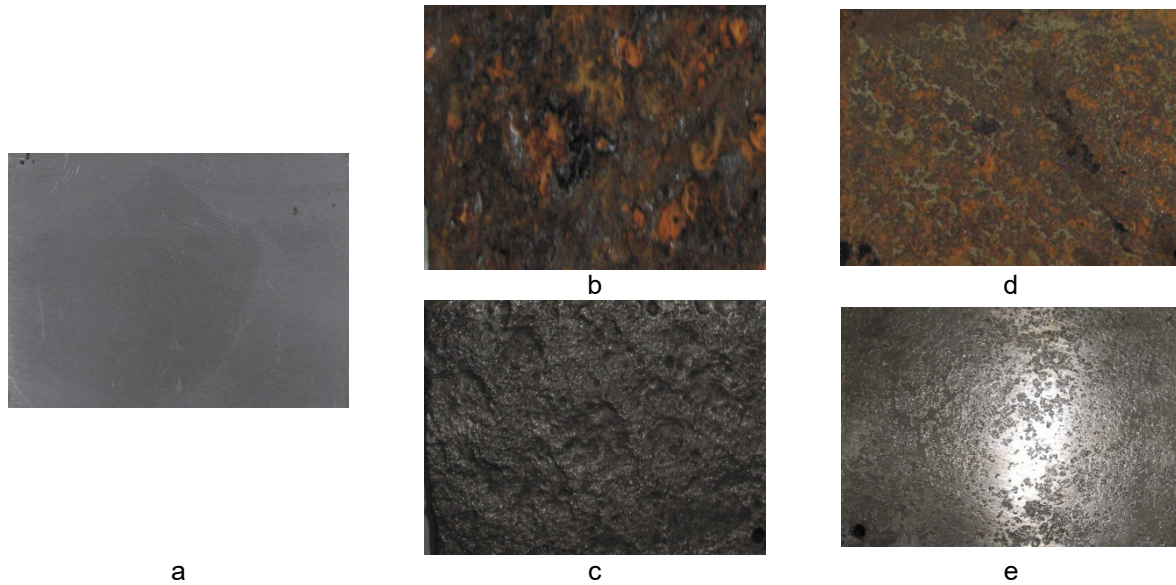
Fig. 3. Appearance of surface of 15HSND steel specimens with polished surface (P) before (a) and after investigations (b, c, d) in the salt fog chamber SF-1 (b, c) and moisture chamber G4 (d, e) during 1200 hours

Photographs of specimens at the initial state (before corrosion tests) with polished surface (**Fig. 3, a**) and surface strengthened by HFMP (**Fig. 4, a**) and after exposure in SF-1 (**Fig. 3, b, c, Fig. 4, b, c**) and G4 (**Fig. 3, d, e, Fig. 4, d, e**) are shown below.

Analyzing the experimental results, it can be noted that after the tests under the influence of neutral salt fog and elevated temperature, all the examined specimens (with surfaces P and P+HFMP) were covered with a thick layer of corrosion products of uneven thickness of brown-black color (**Fig. 3, b, Fig. 4, b**), which were firmly attached to the surface and were very difficult to remove. Areas of the surface without corrosion products with a metallic luster were not observed. After removing the cor-

rosion products, it was noted that the surface is uneven, and corrosion spots are visible over the entire area, with ulcers and pitting inside (**Fig. 3, c, Fig. 4, c**). There are also no areas not affected by local corrosion. Areas with the remains of the reinforcing layer are not visually visible on specimens strengthened by HFMP technology. The corrosion rate after 1200 hours was 2.543 mm/year on the surface of P and 2.096 mm/year on the surface of P+HFMP (**Fig. 5**).

After tests in G4, specimens with the surface P and P+HFMP (**Fig. 3, d, Fig. 4, d**), are covered with an uneven layer of brown corrosion products with black spots. Areas of the surface with almost no corrosion products with a metallic luster are noted, which occupy about 5-7%. After removal of corrosion products, corrosion spots are visible on the surface, smaller in size than after exposure in SF-1, inside some of them pitting has formed, there are areas practically unaffected by local corrosion (**Fig. 3, e, Fig. 4, e**). The corrosion rate was 0.104 mm/year on the P surface and 0.080 mm/year on the P+HFMP surface (**Fig. 5**).

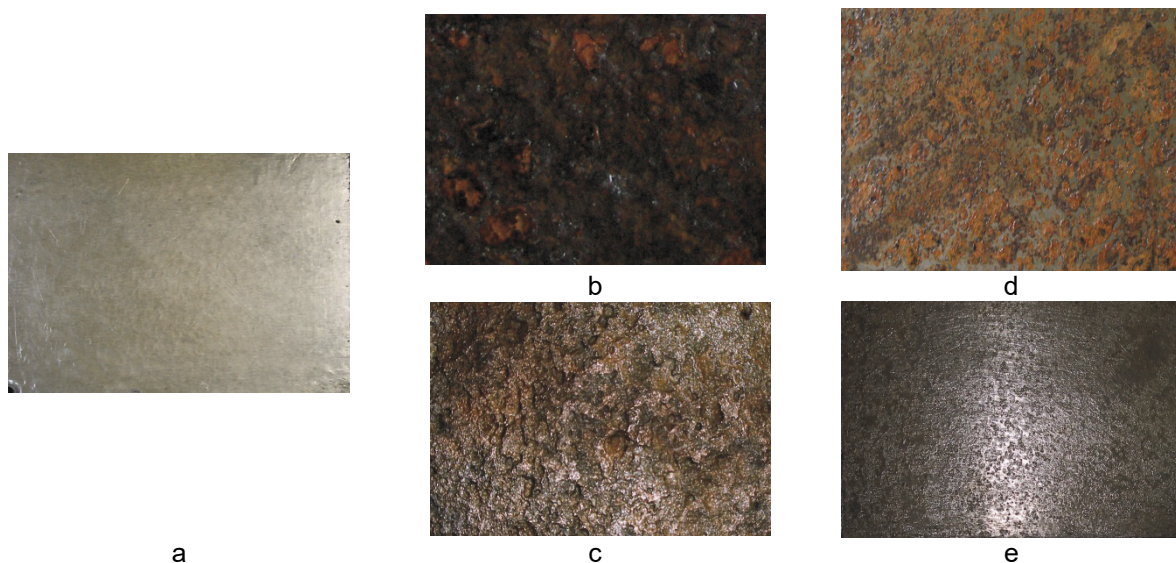
Fig. 4. Appearance of surface of 15HSND steel specimens with surface strengthened by HFMP before (a) and after investigations (b, c, d, e) in the salt fog chamber SF-1 (b, c) and moisture chamber G4 (d, e) during 1200 hours

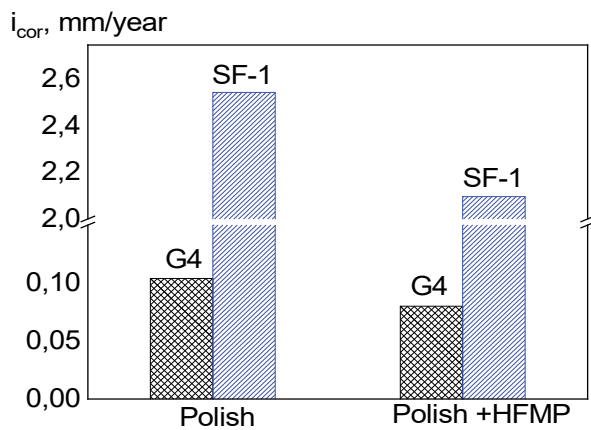
Fig. 5. Comparative diagram of corrosion rate of 15HSND steel with polished surface (P) and surface strengthened by HFMP after accelerated corrosion tests in the salt fog chamber SF-1 and moisture chamber G4 after 1200 hours

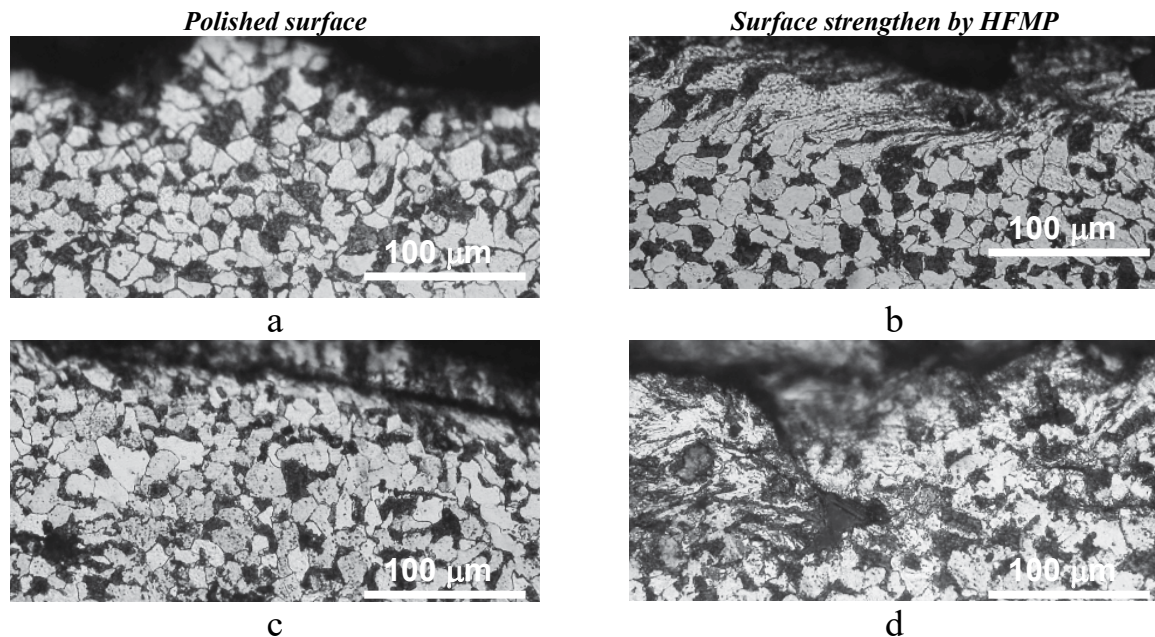
Fig. 6. Microstructure of near surface layers of 15HSND steel with polished surface (P) (a, c) and surface strengthened by HFMP (b, d) after investigations in the salt frog chamber SF-1 (a, b) and moisture chamber G4 (c, d) during 1200 hours.

Some types of surface damage after exposure in SF-1 and G4 are shown in **Fig. 6, b, c**. After exposure in SF-1, continuous uneven corrosion was observed in the surface layers of the specimen with surface P (**Fig. 6, a**), against the background of which deep corrosion lesions were observed in the form of corrosion spots, for example, 2.8 × 0.5 mm, 2.1 × 0.7 mm in size and, less often, corrosion ulcers, for example, in size 1,7 × 1.58 mm. IGC, which started from the boundaries of the ferrite and pearlite grains, and selective corrosion along the pearlite grains were also detected. In addition, in the near-surface layers at a depth of 0.02-0.03 mm, separately located areas with subsurface corrosion from 0.38 mm to 0.413 mm in length were found.

The surface of the specimen P+HFMP was exposed to continuous uneven corrosion (**Fig. 6, b**): mainly, spot corrosion of various sizes, for example, from 0.13×0.03 mm to 1.56×0.26 mm, was detected; in the near-surface layers - by subsurface corrosion of various areas, for example, 0.38×0.012 mm, 0.1×0.007 mm, mainly at a depth of 0.05-0.07 mm, with direct access to the surface of the v; IGC along the boundaries of ferrite grains at a depth of nearly 0.1 mm; selective corrosion of pearlite grains.

In the near-surface layers of the specimen with surface P, continuous uneven corrosion was recorded after the tests (**Fig. 6, c**, and **Table 2**). In addition, relatively shallow (0.03–0.08 mm) corrosion damage is observed, mainly in the form of spots, for example, 0.3×0.05 mm and 0.11×0.017 mm in size; shallow IGC from the boundary of elongated pearlite grains; and more intense selective corrosion along the grains of the pearlite component.

near-surface layers of the specimen with a surface of P+HFMP. The near-surface layers of the specimen were subjected to continuous uneven corrosion (**Fig. 6, d**), relatively shallow (0.026–0.1 mm) spot corrosion was recorded (**Table 2**). In addition, there are areas with subsurface corrosion of different areas, lengths (0.06–0.9 mm), and depths of occurrence (0.01–0.07 mm), both with direct exit and without exit to the metal surface. IGC is not intense and spreads along the boundaries of both ferrite and pearlite grains; selective corrosion of pearlite grains is observed.
