Scientific paper

Zastita Materijala 65 (2)
350 - 359 (2024)

Non-destructive evaluation of subsurface corrosion on hot steel angle sections embedded in concrete and its repair by cement slurry and nitozinc coating

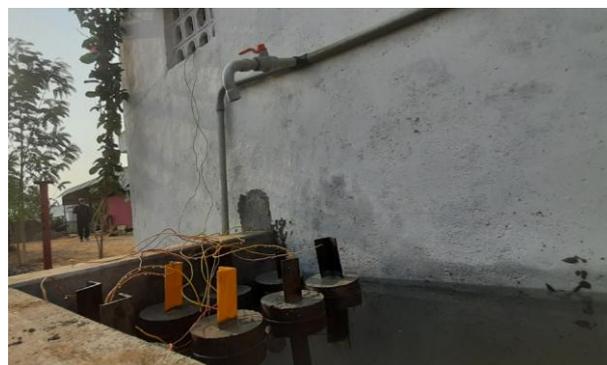
Figure 1. (a) Accelerated corrosion test setup
Slika 1. (a) Ubrzano podešavanje testa korozije

This test method covers the estimation of the electrical half-cell potential of uncoated reinforcing steel in field and laboratory concrete, to determine the corrosion activity of the reinforcing steel [39]. This test method is limited by electrical circuitry. A concrete surface that has dried to the extent that it is a dielectric and surfaces that are coated with a dielectric material will not provide an acceptable electrical circuit [40]. The values stated in inch-pound units are to be regarded as the standard. For the Half-cell potential test, we cast 8 specimens for testing and the test is undertaken after 28 days of providing 2V while curing of specimens. As per ASTM C876 [32] limits below -350mV corrosion does not occur. From the -350mV to -200mV. Probability of occurrence of corrosion when potential head exceeds -200mV. The test setup is shown in Figure 1 and the ASTM standard value is presented in Table 1.

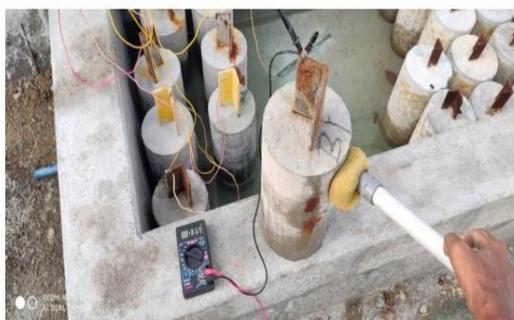
Figure 1. (b) HCP test on corroded specimen

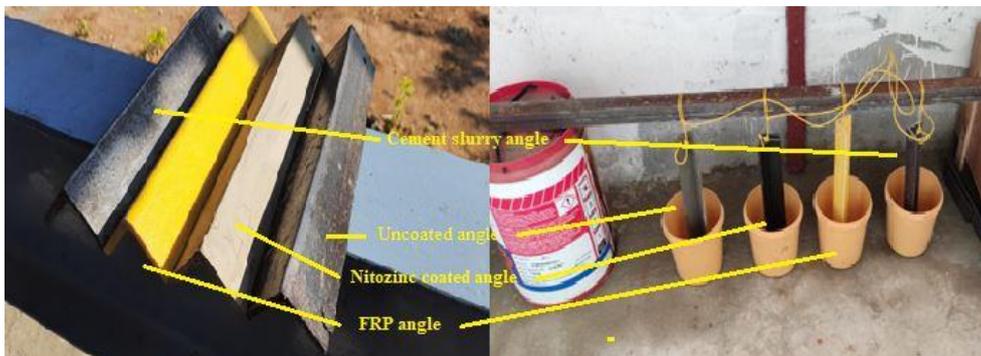
Figure 2. Applied Voltage Test – Setup

Non-conductive plastic material is used in a metallic vessel. The specimens are suspended

vertically in the vessel with at least 25 mm clearance from the bottom. Test specimens are separated by not less than 40 mm [41]. Test specimens shall be separated from any wall of the vessel by not less than 40 mm. The depth of the electrolyte is the test length of the specimen to be immersed, but the immersed area shall not be less than 23, 200 mm². AC power was used for powering the overlays. A VARIAC was used to regulate the applied voltage. A transformer was used to elevate the applied voltage to a maximum of 420 volts. The overlays were connected to the AC power in parallel. An amp-meter was used to record the electrical current going through each overlay. The total current going through both overlays was limited to the maximum capacity of the power source.

Epoxy coatings were applied on the angle for the voltage test. Dimensions of 300mm x 50mm x 6mm angles are used in this test. The effect of electrical and electrochemical stresses on the bond of coating to steel and the integrity of the coating shall be assessed [42]. The test setup is shown in Figure 2. The tests were conducted as per IS 13620:1993. In this test, the coated angles were tested and readings were noted.

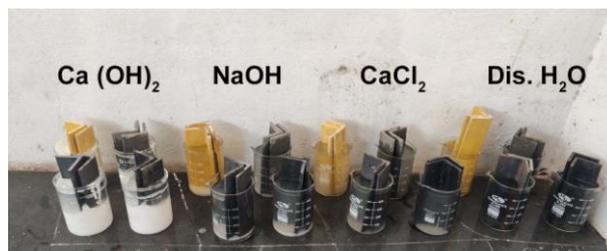
Figure 3. Chemical Resistance test setup

The chemical resistance test, conducted in accordance with IS 13620:1993, is a vital evaluation of coating durability for reinforcing bars. In this test, the coated reinforcing bars are subjected to immersion in various solutions to assess their resistance to chemical corrosion [43]. Figure 3 depicts the test setup of the chemical resistance test. The solutions used include distilled water, a 3M aqueous solution of CaCl₂, a 3M aqueous solution of NaOH, and a solution saturated with Ca(OH)₂. This comprehensive evaluation ensures that the coating can withstand exposure to a range of potentially corrosive

substances. It is important to note that this test is a physical inspection procedure, focusing on the coating's ability to withstand chemical exposure.

Following the designated experimental period, the test examines the formation of any holidays, imperfections, or defects in the coating. After the completion of 45 days, the test setup is meticulously investigated to determine the coating's performance under these challenging conditions, providing valuable insights into its durability and suitability for various applications.

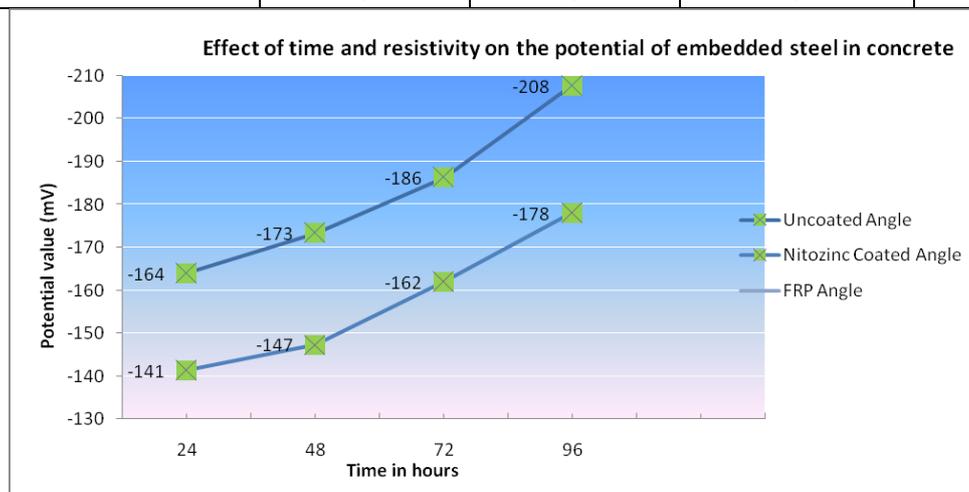
Figure 4. Effect of time and resistivity on the potential of embedded steel in concrete

The presented Table 2, and Figure 4 provide detailed data on the half-cell potential test readings for three types of angle specimens: Uncoated Angle, Nitozinc Coated Angle, and FRP (Fiber-Reinforced Plastic) Angle.

Uncoated Angle: The readings for the Uncoated Angle exhibited consistently negative potentials throughout the 6-hour test period, with values ranging from -159 to -218mV. These negative potential values suggest that the Uncoated Angle is susceptible to electrical conduction, and the increasing negative potential values signify the material's gradual degradation over time. This electrical conductance points to the angle's vulnerability to corrosion, making it an unfavorable choice for applications that require corrosion resistance.

Nitozinc Coated Angle: In contrast, the Nitozinc Coated Angle displayed positive potentials throughout the test, with values ranging from -142 to -184 mV. These consistent positive potentials signify the angle's ability to resist electrical conduction, indicating its corrosion resistance. The Nitozinc Coating effectively maintained its electrical integrity over the testing duration, highlighting its suitability for applications where corrosion resistance is of utmost importance.

FRP Angle: The FRP Angle consistently registered at zero amperes during the entire test period, signifying its complete lack of electrical conduction. This property underscores the angle's electrical non-conductivity, making it an ideal choice for applications where electrical insulation is a critical requirement.

The half-cell potential test results provide valuable insights into the electrical conductance and corrosion resistance of the tested angle materials. While the Uncoated Angle displayed negative potentials and susceptibility to corrosion, the Nitozinc Coated Angle demonstrated positive potentials and resistance to electrical conduction. The FRP Angle's consistent zero amperes confirmed its electrical non-conductivity. Nitozinc Coating is resistive against corrosion compared to Uncoated steel angles. FRP angle does not conduct any current.

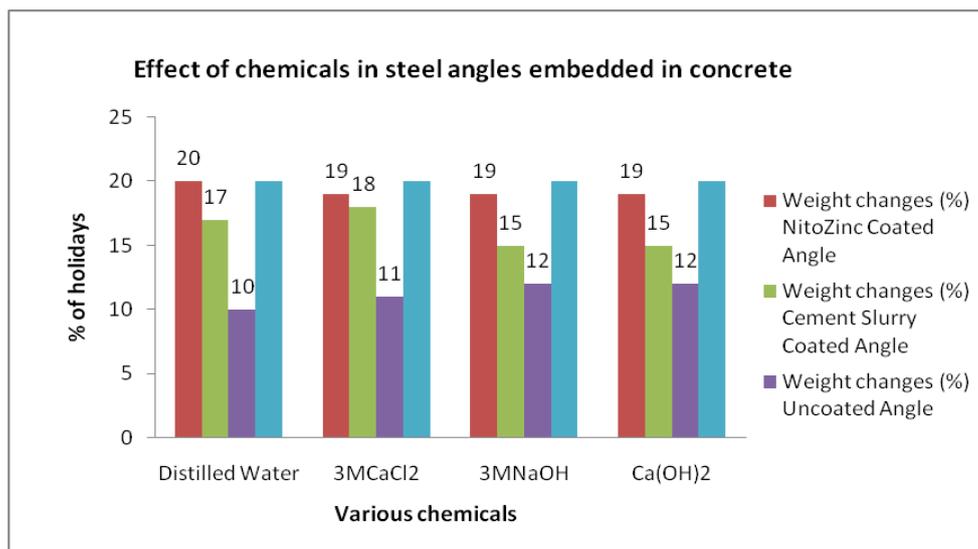
Figure 5. Effect of chemicals in steel angles embedded in concrete

Cement Slurry Coated, Uncoated, and FRP Angles. The experiment involved immersing these angles in four different solutions: Distilled Water, 3M CaCl₂, 3M NaOH, and Ca(OH)₂. The study was conducted over a specified period, and the results are summarized in the table below, indicating the number of angles that exhibited specific characteristics after exposure to each solution. In the case of NitoZinc Coated Angle, the weight changes after exposure to these solutions were as follows: 20% for Distilled Water, 19% for 3M CaCl₂, 19% for 3M NaOH, and 19% for Ca(OH)₂. For Cement Slurry Coated Angle, the weight changes were 17% for Distilled Water, 18% for 3M CaCl₂, 15% for 3M NaOH, and 15% for Ca(OH)₂. Uncoated Angle displayed weight changes of 10% for Distilled Water, 11% for 3M CaCl₂, 12% for 3M NaOH, and 12% for Ca(OH)₂. Lastly, the FRP Angle exhibited consistent weight changes of 20% for all the tested solutions. The graphical representation of test results is shown in Figure 5.

NitoZinc Coated Angle showed no significant weight change (20%). This indicates its excellent resistance to pure water, suggesting that the coating effectively protects the underlying material from corrosion in a water-rich environment. Cement Slurry Coated Angle exhibited a relatively small weight change (17%), implying good resistance to pure water, although slightly less effective than NitoZinc Coated Angle. The uncoated Angle experienced a moderate weight change (10%). While it's less susceptible to water than coated angles, this change suggests potential vulnerability to water-induced corrosion over time. FRP Angle demonstrated no significant weight change (20%), indicating its exceptional water resistance. This material is ideal for applications requiring high water resistance.

NitoZinc Coated Angle displayed a minor weight change (19%), signifying good resistance to chloride-rich solutions. Cement Slurry Coated Angle exhibited a slightly higher weight change (18%), indicating slightly reduced resistance to calcium chloride compared to NitoZinc Coated

Angle. Uncoated Angles showed a moderate weight change (11%), suggesting moderate susceptibility to chloride-induced corrosion. FRP Angle experienced no significant weight change (20%), showcasing its excellent resistance to calcium chloride.

NitoZinc Coated Angle demonstrated a slight weight change (19%), suggesting good resistance to alkaline conditions. Cement Slurry Coated Angle had a relatively higher weight change (15%), indicating it might be slightly more vulnerable to sodium hydroxide. The uncoated Angle showed a moderate weight change (12%), implying some vulnerability to strong alkali. FRP Angle displayed no significant weight change (20%), highlighting its strong resistance to alkaline solutions.

NitoZinc Coated Angle showed minimal weight change (19%), emphasizing its resistance to highly alkaline environments. Cement Slurry Coated Angle exhibited a slightly higher weight change (15%), indicating it can withstand alkaline conditions. Uncoated Angle displayed a moderate weight change (12%), suggesting it might be moderately susceptible to strong alkalinity. FRP Angle showed no significant weight change (20%), underscoring its resistance to highly alkaline solutions.

These scientific observations reveal the chemical resistance and durability of the tested angle materials in different environmental conditions. NitoZinc Coated Angle and FRP Angle consistently exhibited strong resistance across various chemicals does not produce any holidays making them suitable for applications demanding robust corrosion resistance. On the other hand, Uncoated Angle and Cement Slurry Coated Angle showed large number of holidays showing varying degrees of susceptibility to different chemicals and loss of weight, underlining the importance of protective coatings and material selection for specific industrial contexts.
