Scientific paper

Zastita Materijala 61 (4)
328 - 338 (2020)

Stress corrosion resistance of welded joints of low-alloy pipe steel produced by high frequency welding

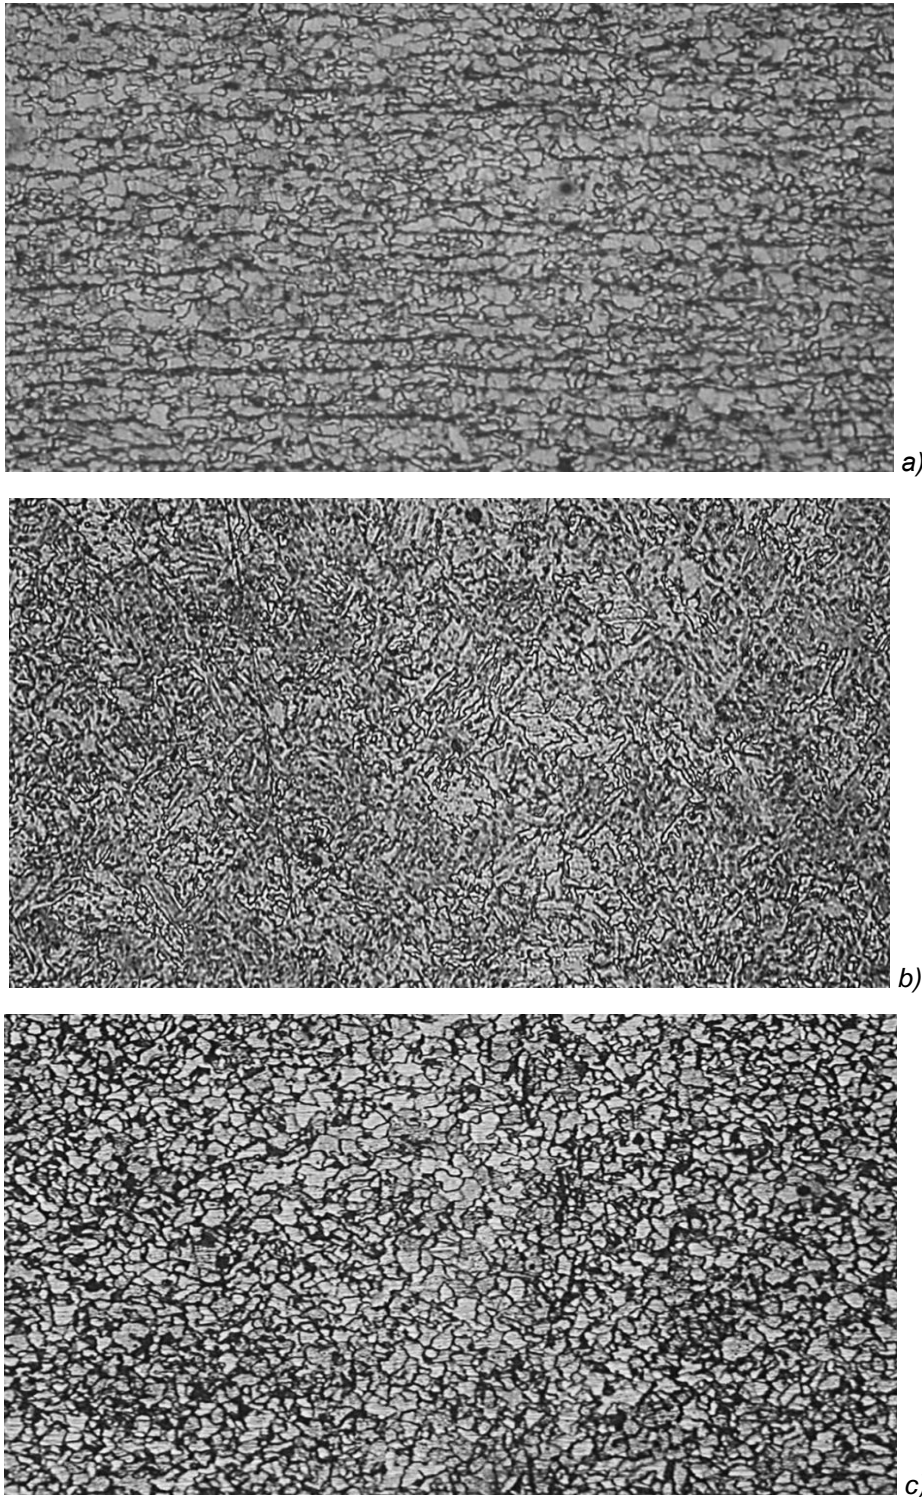
Figure 1. Microstructure of different zones of HF welded joints of 17G1S-U steel:
1 – base metal; 2 – welded joints without LHT; 3 – welded joints after LHT

According to the results of metallographic examinations, it was found that the structure of the base metal of the pipes represented a mixture of fine-grained ferrite and perlite with a ferrite grain of 9-10 number (Fig.1a). The banding of the steel is characterized by the ball 4-5 according to the scale 3 GOST 5640 [29].

The contamination of the base metal occurs locally in separate zones – by slag inclusions, tiny globular oxides, elongated oxides, including those near the fusion zone (Fig. 1).

The structure of the welded joint without LHT is characterized by heterogeneity (Fig. 1b). Moreover, a significant delamination of the structure into

separate zones is revealed: zone of fusion (a lighter layer with a low-carbon structure), zone of overheating and zone of partial recrystallization.

During a local heat treatment heating of welded joints occurred over the entire thickness of the pipes wall. The fusion line of welded joints in the form of a light decarburized band is almost perpendicular to the surface of the pipe, it may have a slight curvature. The zone of heat treatment in welded joints may be both symmetric and asymmetric. At the LHT zone, the metal microstructure represents a typical fine-grained ferrite-pearlite mixture (Fig.1c). The local heat treatment of welded joints certainly improves the metal structure of welded joints. The total width of the LHT zone on the outer surface of the pipe is (19-23) mm, and on the inner it is (10-13) mm. Based on the available experience, as the optimal zone of local heat treatment is considered, at which its width from the inner and outer side of the pipe is provided to be close as to its sizes.

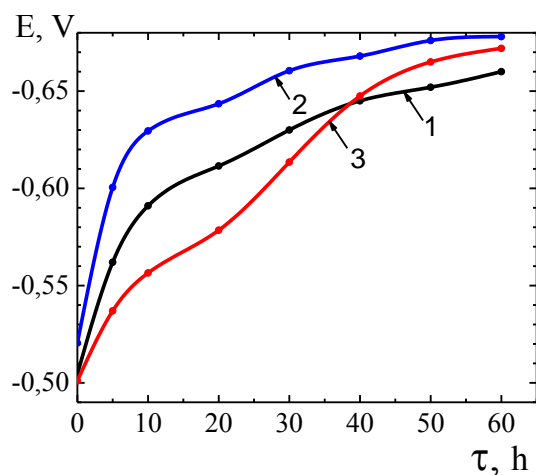
Figure 2. Change of corrosion potential with time, measured in different zones of welded joints: 1 – base metal, 2 – welded joint without LHT, 3 – welded joint after LHT.

The corrosion potentials of the specimens of the base metal and welded joints were determined. From the analysis of the experimental data it follows that the potential difference between the weld of the specimens without LHT and those with LHT and the base metal does not exceed (30-50) mV (Table 3 and Fig.2, 3). According to GOST 9.005 [30] (paragraph 4.4.5), such welded joints are corrosion resistant.

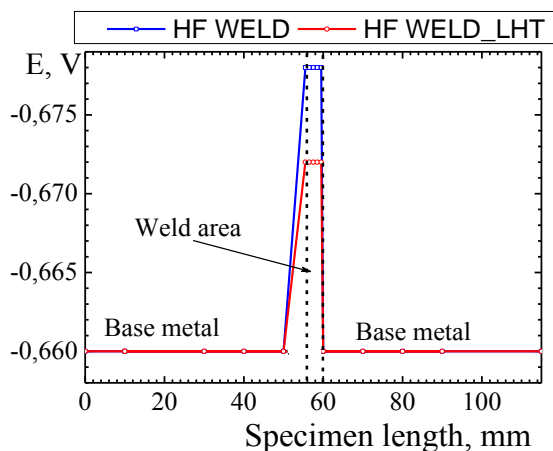
Figure 3. Change of corrosion potential along the length of welded joints

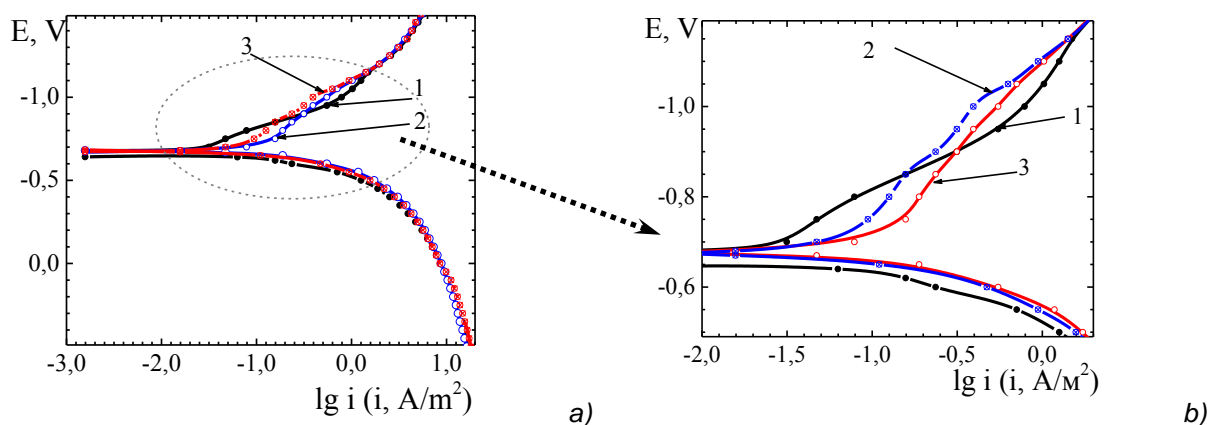
Figure 4. Polarisation curves of different zones of welded joints of 17G1S-U steel in the 3 % NaCl solution: 1 – base metal; 2 – welded joints without LHT; 3 – welded joints after LHT

The polarization curves are shown in Fig. 4. From their analysis it is seen that the character of the anode and cathode curves of both the base metal and the welds is the same. The value of the limiting current of oxygen reduction on the base metal is 2.5-3.4 times lower than in the area of the welds (0.047, 0.12 and 0.16 mA/m², respectively), Table 3. Since, under the conditions of a free access of oxygen in aqueous solutions, the corrosion proceeds with a diffusion control, higher

currents of oxygen reduction in the welds area can contribute to accelerating the corrosion process in this area, which needs a greater attention. The potentials of the beginning of hydrogen evolution on the welds about (8-15) mV are more negative than on the base metal, Table 2.

Analyzing the behaviour of the anode curves, it is possible to note the area of active dissolution, from the corrosion potential to -0.5V (Fig.4, curves 1-3).

times lower than that of the weld without LHT and with LHT, respectively, Table. 3. At the potentials higher than -0.5V, a slow anodic dissolution was observed, predetermined by shielding the surface with the iron corrosion products.

A slightly higher value of the rate of corrosion of the welded joint with LHT at all the studied load levels correlates with the results of electrochemical data, Fig. 4. But in general, it should be noted that resistance of the welded joint, made in accordance with the factory technology, to corrosion-mechanical fracture in the 3% NaCl solution is at the level of the base metal. Despite a local decrease in the observed values of impact strength, the overall corrosion resistance of this welded joint is satisfactory in general. It should be noted that those data were obtained for the grinded state of the surface. During operation, as a result of the formation of probable surface irregularities in the weld area, the localization of the corrosion process is not excluded.

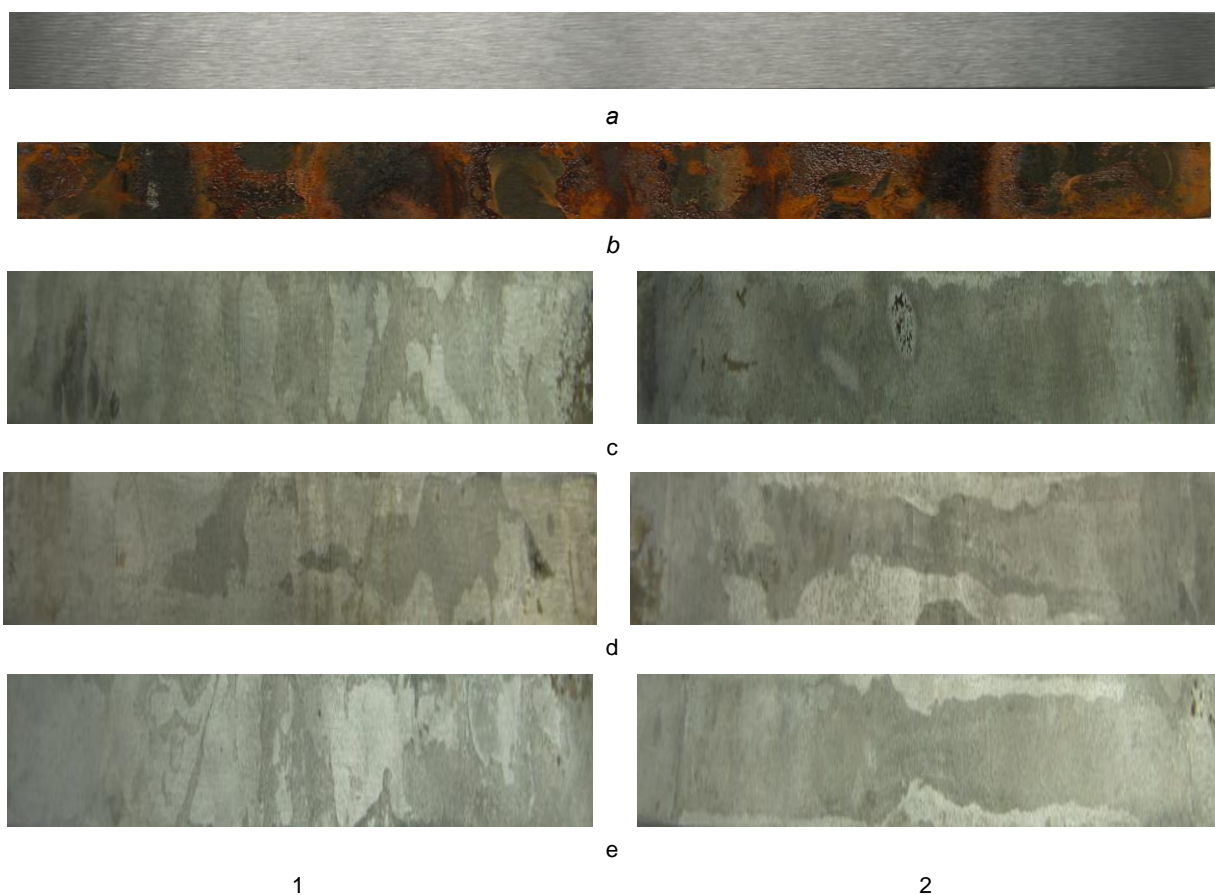
Figure 5. Appearance of the surface of specimens of 17G1S-U steel before (a) and after corrosion and corrosion-mechanical tests (b – e) during 1000 h in the 3% NaCl solution: 1 – in unstressed state; 2 – in stressed state; a – before the tests; b – after the tests without a removal of corrosion products; c – base metal; d – welded joint without LHT; e – welded joint after LHT

After removal of corrosion products on the surface, corrosion spots of different sizes were revealed, Figure 5). The spots are visually characterized by a change in colour of the surface layer (darkening) with a very small depth of damage. On the surface of some specimens, small corrosion ulcers with a diameter from 1 to 4 mm were formed. The localization of corrosion damages and a predominant corrosion fracture in the weld were not observed.

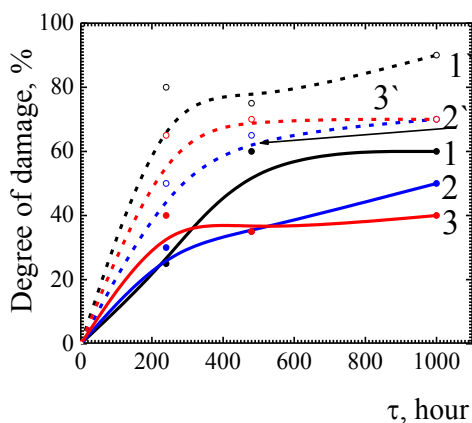
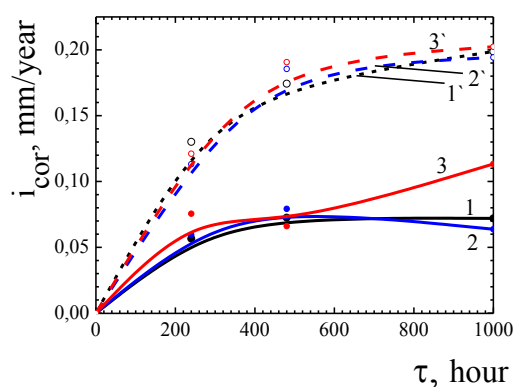
Figure 6. Degree of surface damage by corrosion (a) and corrosion resistance (b) of the base metal and welded joints of 17G1S-U steel after corrosion-mechanical tests in the 3% NaCl solution: 1, 1' is the base metal in the unstressed and stressed states; 2, 2' is the welded joint without LHT in the unstressed and stressed states; 3, 3' is the welded joint after LHT in the unstressed and stressed states

The degree of damage of the specimen surface by corrosion spots was slightly different for the specimens in the unstressed and those in the stressed states: in general, the area of the unstressed specimens covered by corrosion spots ranged approximately from 40 to 50% and that of the stressed ones – from 70 to 90%, Fig. 6 a.

the acceleration of corrosion of welded joints with LHT to about 60% is observed, which correlates with the results of electrochemical tests. According to the corrosion-resistance scale for metals [19], the corrosion resistance of the base metal and the welded joint without LHT after 1000 hours was evaluated by the ball 5, and the metal was evaluated as "stable", and that of the welded joint with LHT was evaluated by the ball 6, which corresponded to the resistance group "reduced resistant" (Fig. 6, b).

When the specimens are loaded to the level of 0.95 from the yield point of the base metal, the rate of continuous corrosion after 1000 h increases by 1.7-3 times, Fig. 6, b: from 0.072, 0.064 and 0.116 mm/year in the unstressed state (base metal, welded joint without LHT and welded joint with LHT, respectively) to 0.199, 0.194 and 0.202 mm/year in the stressed state, respectively. The corrosion resistance of all the specimens is evaluated by the ball 6, which corresponds to the "reduced resistant" metal.

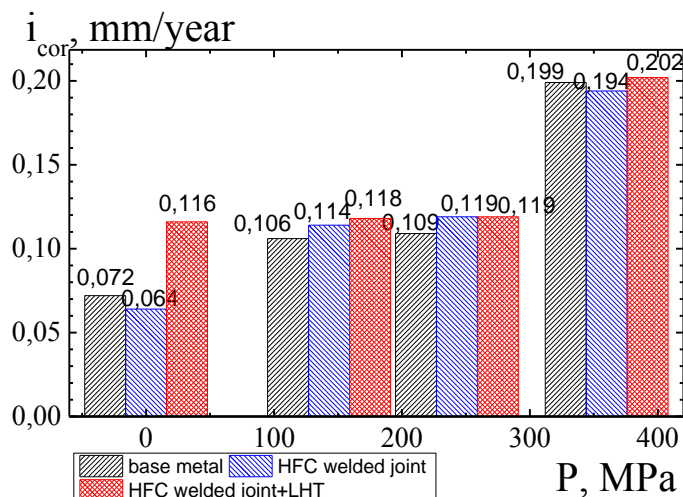
Figure 7. Effect of the load level on the resistance to corrosion of the base metal and welded joints of 17G1S-U steel

point. It was found that the rate of continuous corrosion of both types of welded joints (without LHT and with LHT) and that of the base metal is almost the same, Fig. 7.
