Scientific paper

Zastita Materijala 60 (2)

Analysis of the heat affected zone in plasma jet cutting process of the aluminium alloy EN AW 5083

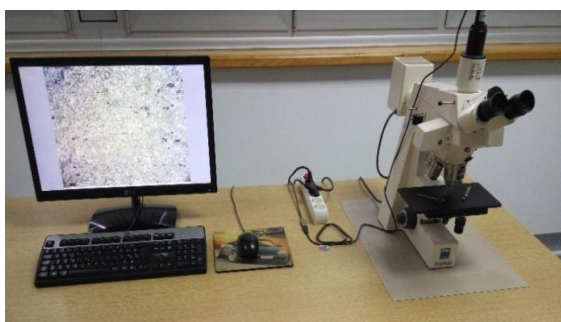
Figure 1. OPTON Axioskop optical microscope
Slika 1. OPTON Axioskop optički mikroskop

The metallographic analysis was done on optical microscope OPTON Axioskop with connected DinoEye digital camera (Figure 1).

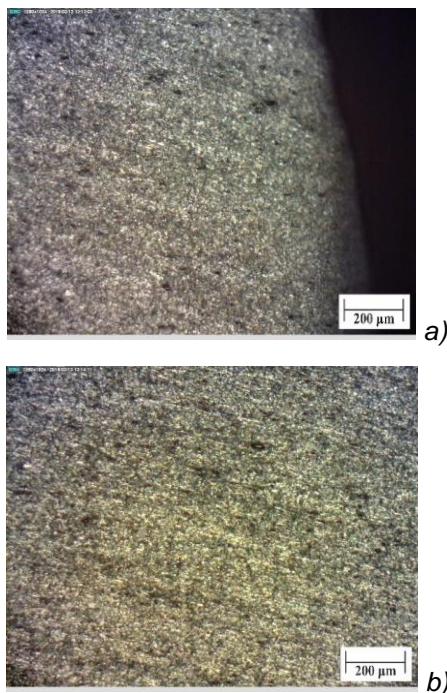
Figure 2. Metallographic image of: a) heat affected zone and b) base material for the sample No. 9

The metallographic analysis results for chosen samples are presented on Figures 2 and 3.

On all of the metallographic images obtained, beside usually expected phases in the material structure, the existence of dark areas (inclusions), was noticed. For the purpose of properties analysis of the mentioned structural features, micro-hardness testing was conducted with 98.07 mN load applied (HV 0.01), figure 9. In this figure, the indentation mark of micro-hardness measurement for usual phases was noted with a circle, with obtained values of 78 HV0.01. On the same figure, the indentation marks of micro-hardness measurements for dark areas were noted with squares. Obtained values were 95 HV0.01. The results have showed that dark areas do not represent any form of porosity in the material structure. It is possible that these areas imply certain precipitates. For more precise definition, SEM analysis ought to be conducted.

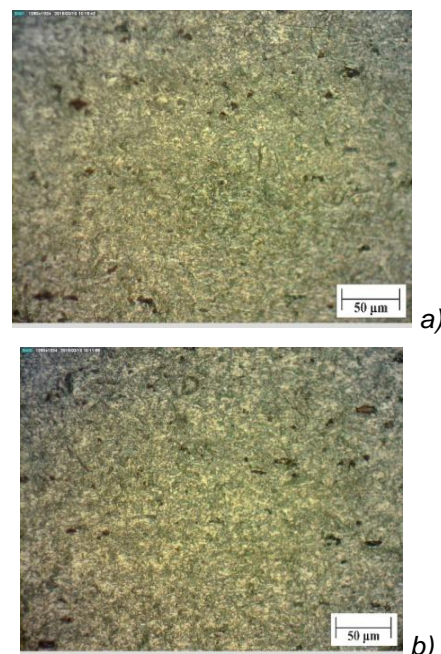
Figure 3. Metallographic image of: a) heat affected zone and b) base material for the sample No. 6

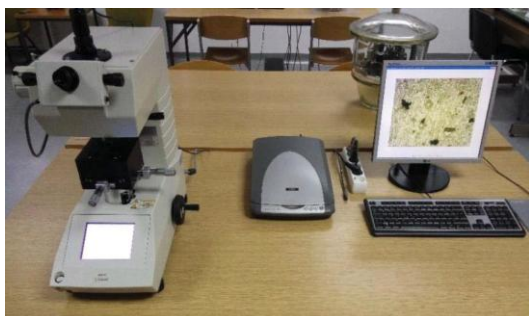
Figure 4. Micro hardness tester Shimadzu HMV-2T

Hardness testing was carried out on microhardness tester Shimadzu HMV-2T (Figure 4), with testing load of 9.8 N (HV1), in distances of 0.3 mm from the cutting edge towards center of the samples. For each of the gained hardness values, 3 measurements were done (Figure 5).

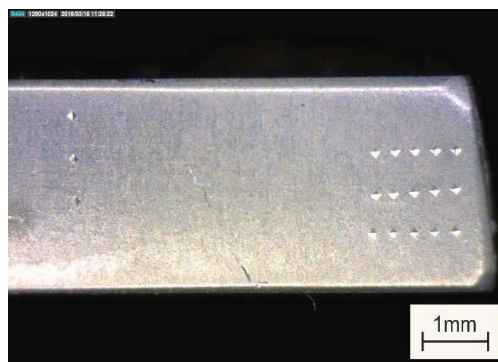
Figure 5. Micro-hardness testing positions

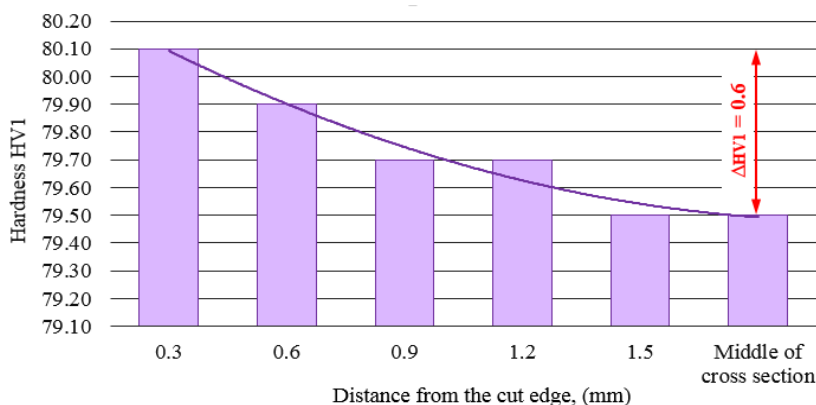
Figure 6.1. Diagram of micro-hardness value change dependency on the increase of distance from cutting edge - sample No. 1

The average values of measured hardness are given in Table 2. Based on obtained results, the histogram diagrams of micro-hardness values change dependency on distance of the cutting

edge (Figure 6.1. - 6.9) and different cutting process input parameters (Figure 6.1. - 6.9, 7 and 8), are presented.

The difference between maximum measured hardness at 0.3 mm distance from the cutting edge and the hardness measured at the center of the sample is also shown on Figures 6.1. - 6.9.

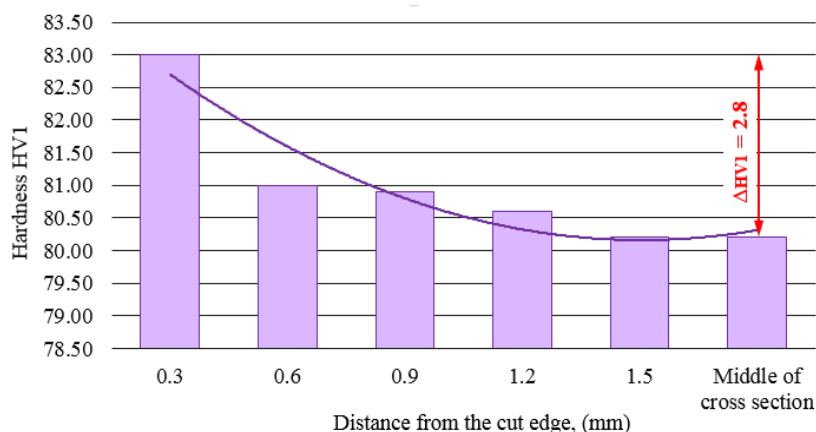
Figure 6.2. Diagram of micro-hardness value change dependency on the increase of distance from cutting edge - sample No. 2

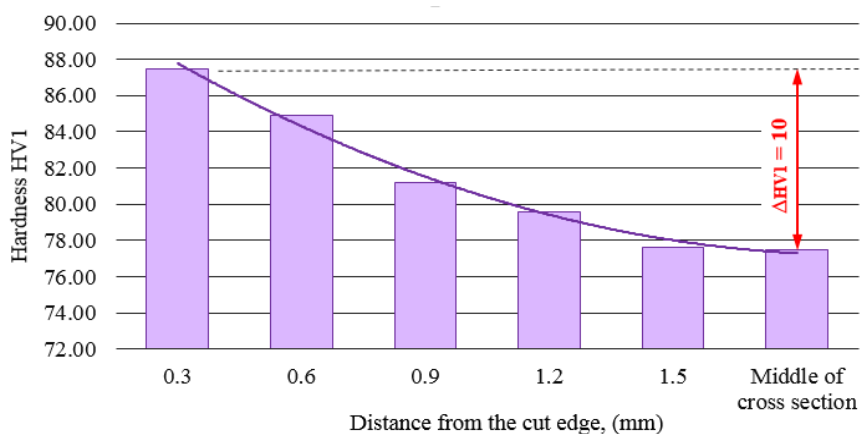
Figure 6.3. Diagram of micro-hardness value change dependency on the increase of distance from cutting edge - sample No. 3

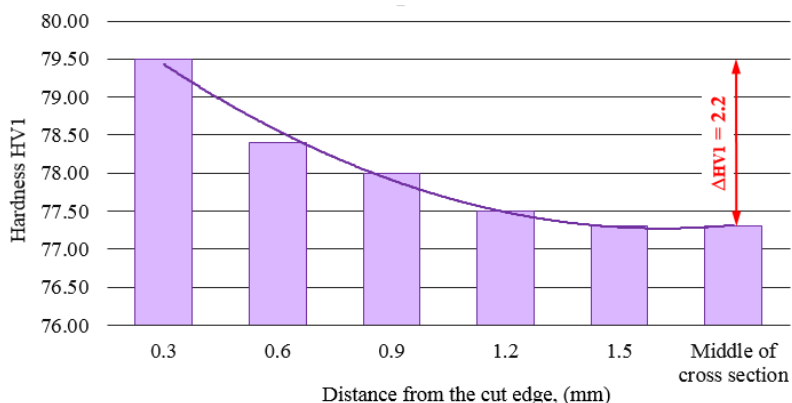
Figure 6.4. Diagram of micro-hardness value change dependency on the increase of distance from cutting edge - sample No. 4

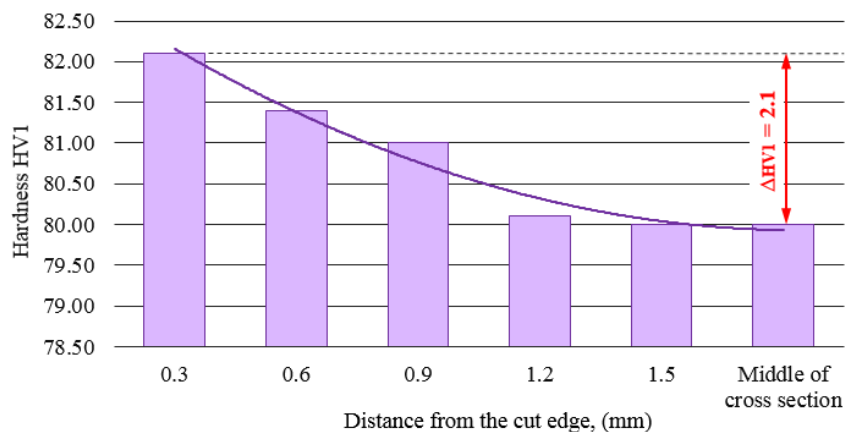
Figure 6.5. Diagram of micro-hardness value change dependency on the increase of distance from cutting edge - sample No. 5

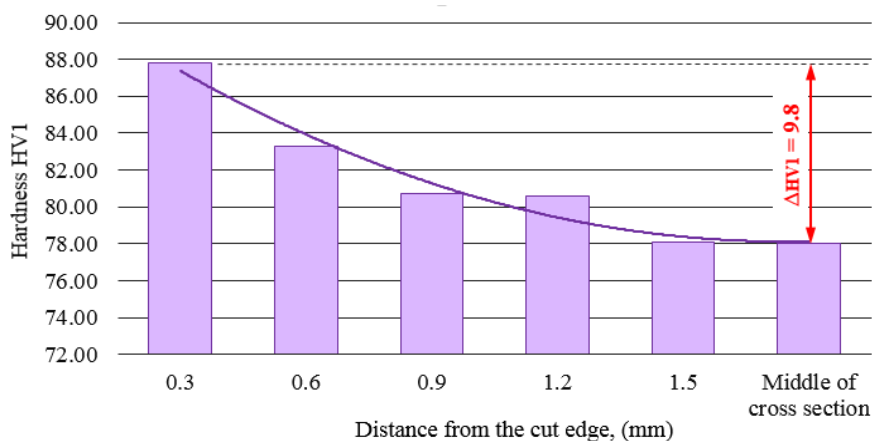
Figure 6.6. Diagram of micro-hardness value change dependency on the increase of distance from cutting edge - sample No. 6

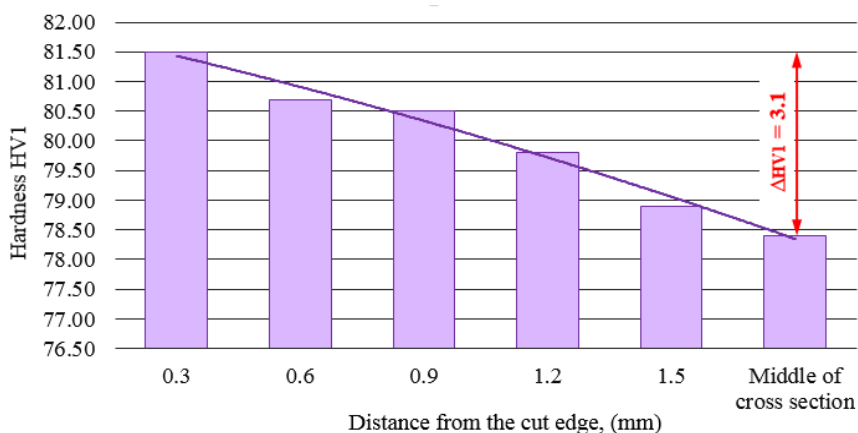
Figure 6.7. Diagram of micro-hardness value change dependency on the increase of distance from cutting edge - sample No. 7

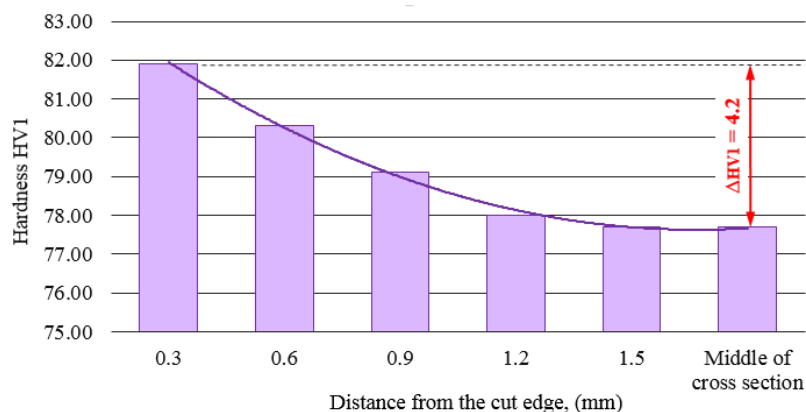
Figure 6.8. Diagram of micro-hardness value change dependency on the increase of distance from cutting edge - sample No. 8

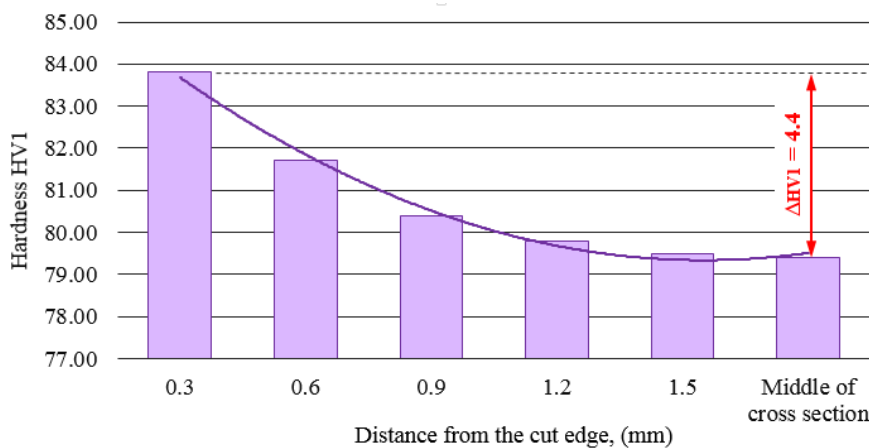
Figure 6.9. Diagram of micro-hardness value change dependency on the increase of distance from cutting edge - sample No. 9

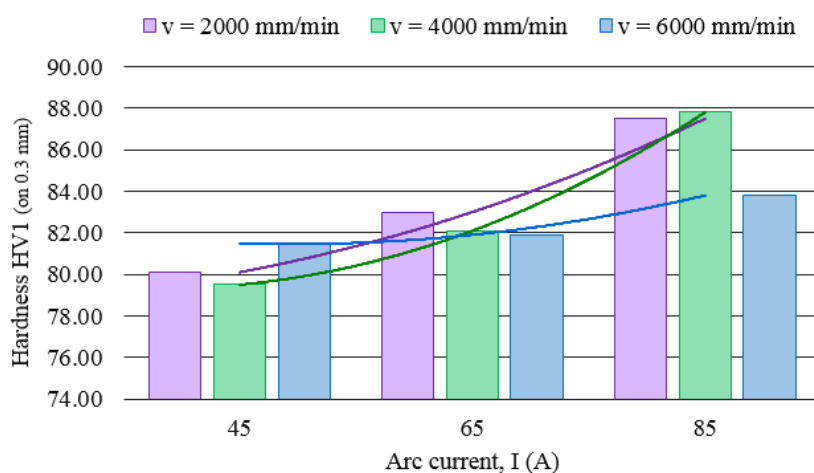
Figure 7. Diagram of micro-hardness value change dependency on electric current change for different values of cutting speed

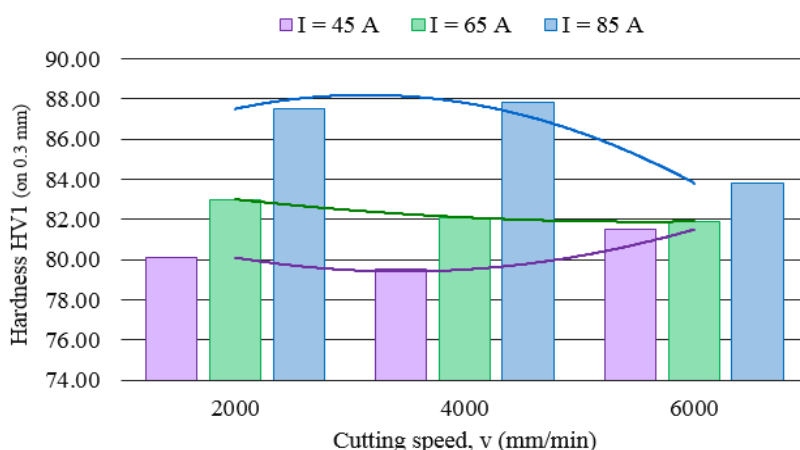
Figure 8. Diagram of micro-hardness value change dependency on cutting speed change for different values of electric current

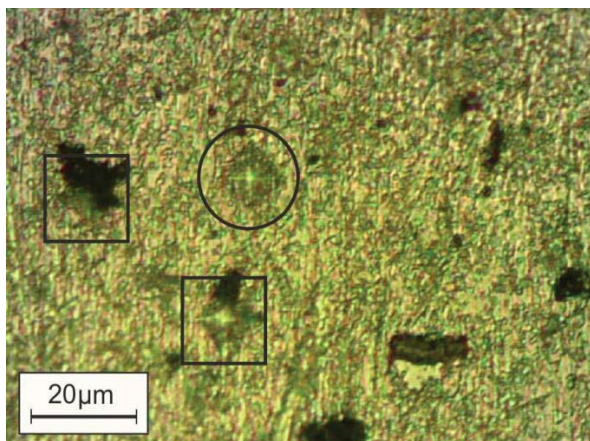
Figure 9. Micro-hardness testing of different phases in material structure
